Weatherization Assistance in Palm Bay

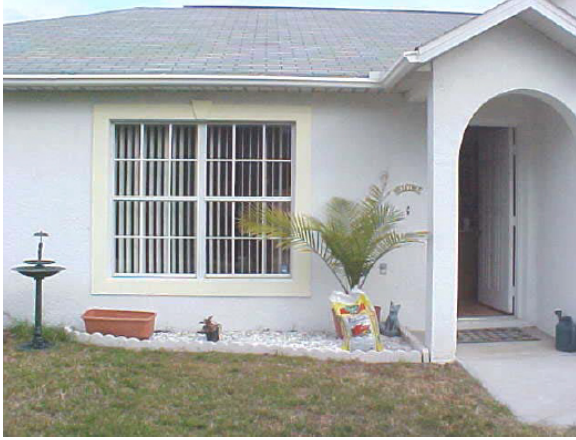
Figure 1 – Before. Old front door.

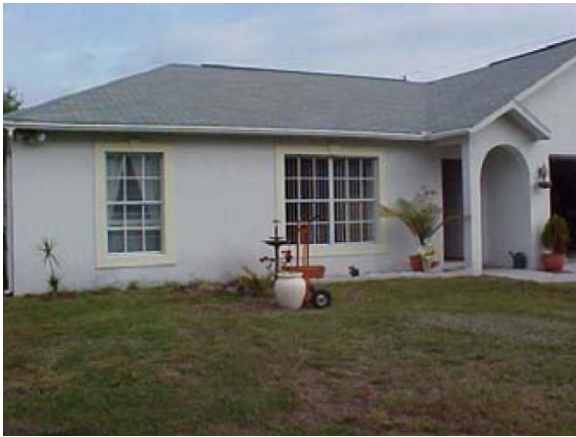
Figure 3 - Before. House without solar screens.

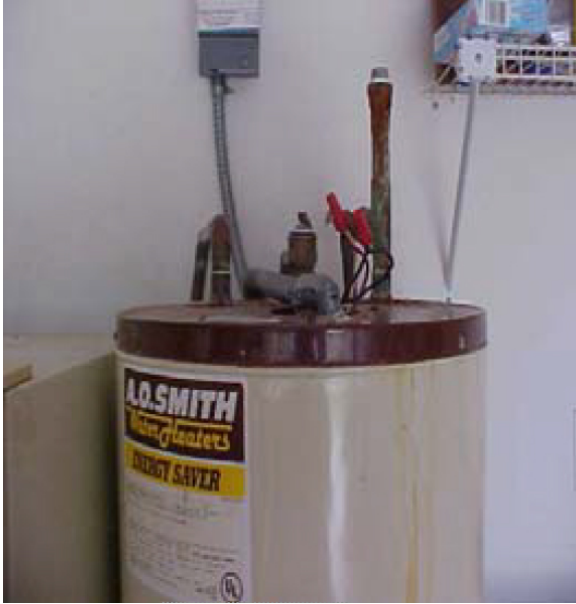
Figure 5 - Before. Old, rusted, electric water heater.

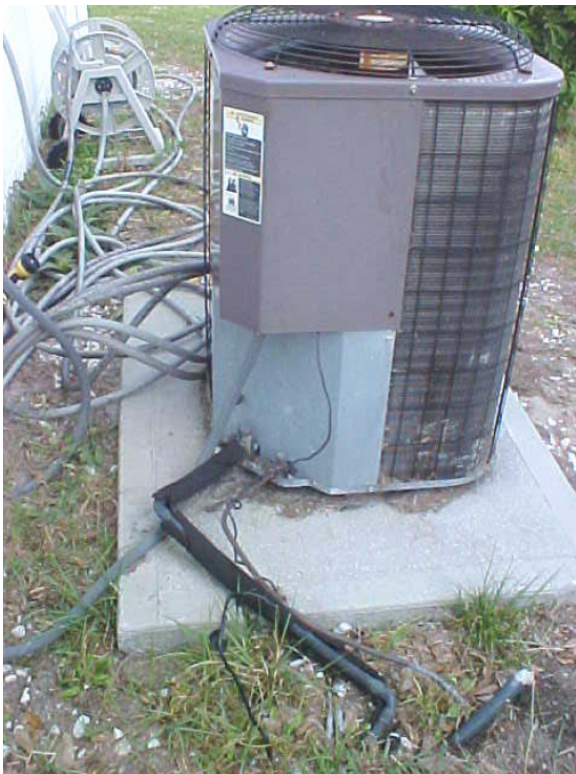
Figure 7 - Before. Outdoor air conditioning unit with exposed, worn out pipes.
